**CARBON SIX
CONSTRUCTION**

Framing/MEP Report w Pickup List Addendum

35 Amberwood
Anycity ST
12345

Inspected by: CI Demo
Prepared By: Mary Peterson
Company: Carbon Six Construction
Date Published: 06/12/2014
Date of Inspection: 06/11/2014
Prepared for: Owner

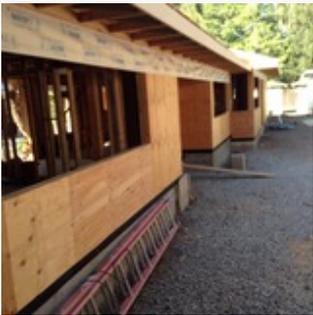
06/12/2014 00:59 (UTC)	Foundation	The foundation work is all completed.

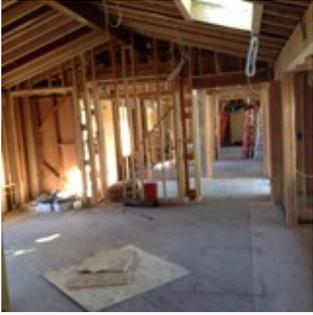
06/12/2014 00:59 (UTC)	Framing	The framing work is mostly completed. The blocking stall to be completed. The roof sheathing needs to be nailed off.

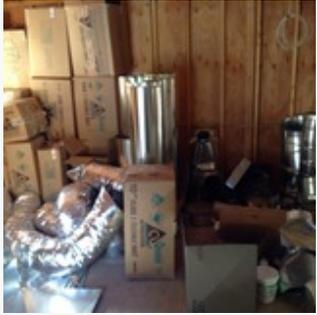
<p>06/12/2014 01:00 (UTC)</p>	Mechanical Rough-in	<p>The mechanical rough-in is in progress. The photo shows equipment components staged for installation.</p> <p>Contractor believes that he is approximately 50% complete with rough-in.</p>

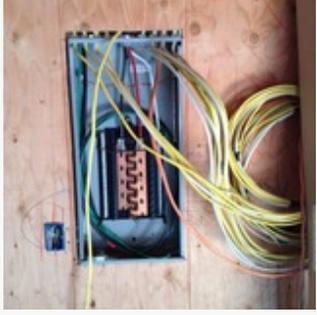
<p>06/12/2014 01:02 (UTC)</p>	Electrical Rough-in	<p>The electrical rough-in is in progress. The contractor is approximately 80% complete; garage main panel still to be wired, some exterior work still to be completed and the triple meter not yet installed.</p>

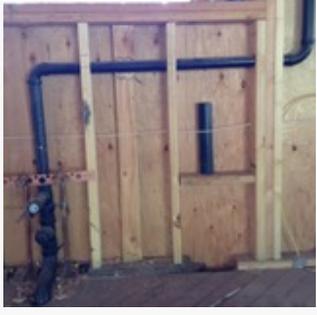
<p>06/12/2014 01:01 (UTC)</p>	Plumbing Rough-in	<p>The plumbing rough-in has been completed. Approved by the building inspector and ready for the next phase of construction.</p>

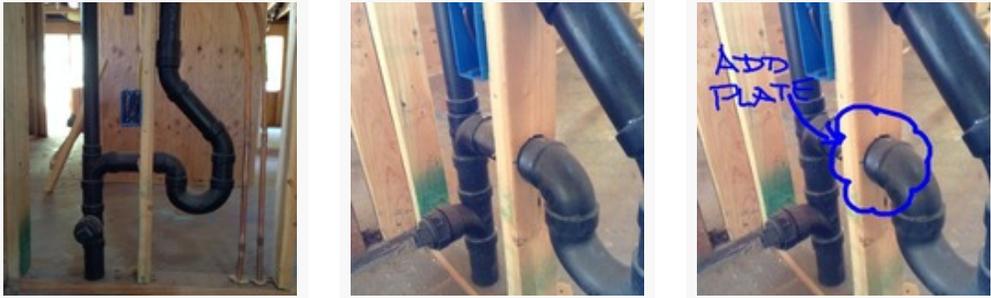
<p>06/12/2014 00:53 (UTC) 06/12/2014 00:53 (UTC) 06/12/2014 00:54 (UTC)</p>
Recess Washer Outlet	<p style="text-align: center;">OK</p>

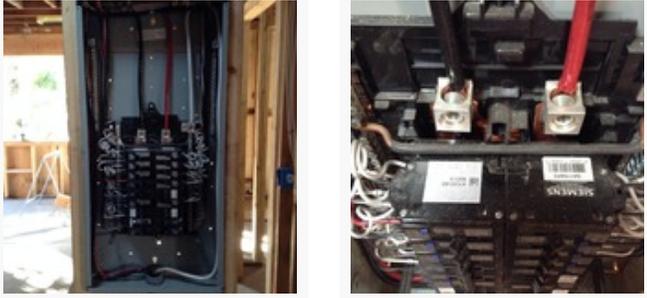
<p>06/12/2014 00:54 (UTC)</p>
Electric Panel	<p style="text-align: center;">Incomplete</p> <p>Electric main panel wiring is in progress. Number terminations have been completed; some wiring still needs to be terminated, and grommet at bottom of panel need to be installed.</p>

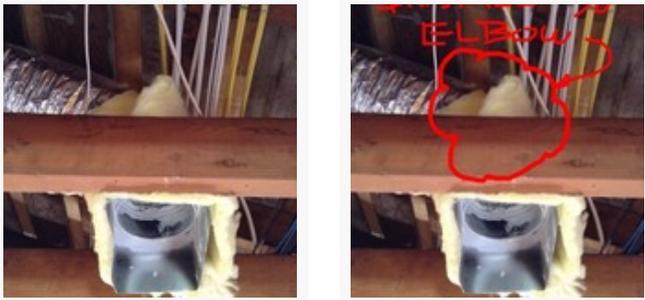
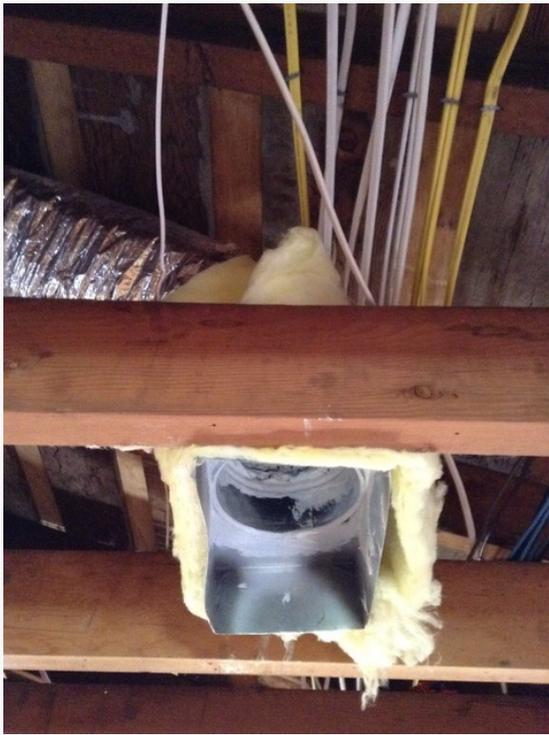
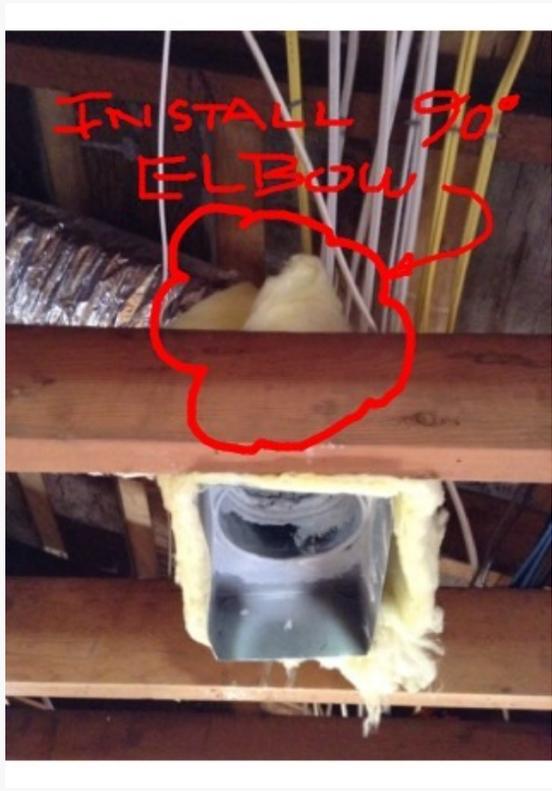
Flagged</p> <p>The register has been installed without a proper 90-degree elbow. The insulation is exposed, needs to be wrapped.</p>

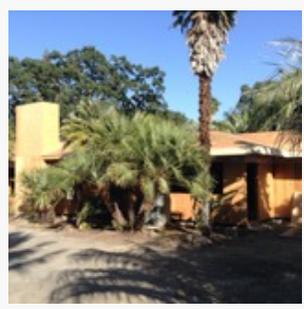
Item	Description
Gapped Shear Panels	<p>plywood Replace

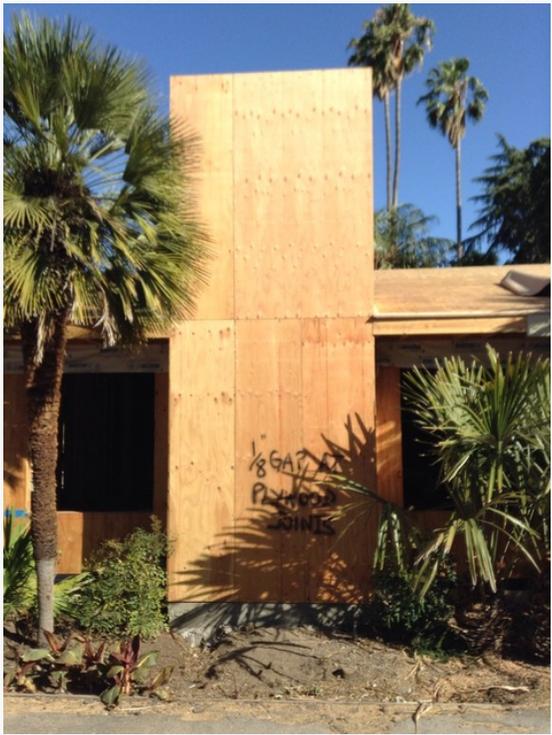
<p>06/12/2014 00:50 (UTC)</p>				
Front Elevation: Gapped Shear Panels	<table border="1"> <tr> <td data-bbox="298 1310 695 1438">plywood</td> <td data-bbox="695 1310 1187 1438">Replace</td> <td data-bbox="1187 1310 1360 1438"></td> <td data-bbox="1360 1310 1523 1438">Flagged</td> </tr> </table>	plywood	Replace		Flagged
plywood	Replace		Flagged
