In-going

9 Tokai Road
Constantia
Cape Town
7700

Date Published: 31 March 2015

Date of Inspection: 31/03/2015

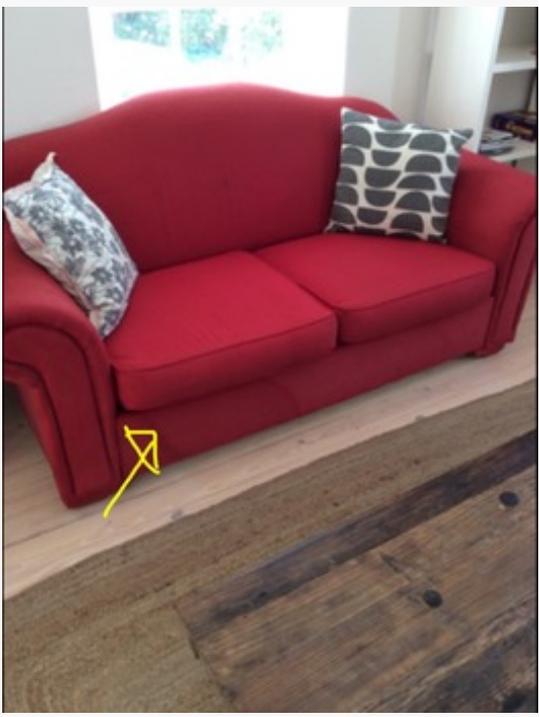
<p>There are water marks on the red sofa, on the front side and on the arm side. 31/03/2015 09:51 (CAT) at -34.1256150758713 ° , 18.4497218673937 °</p> </div> </div>

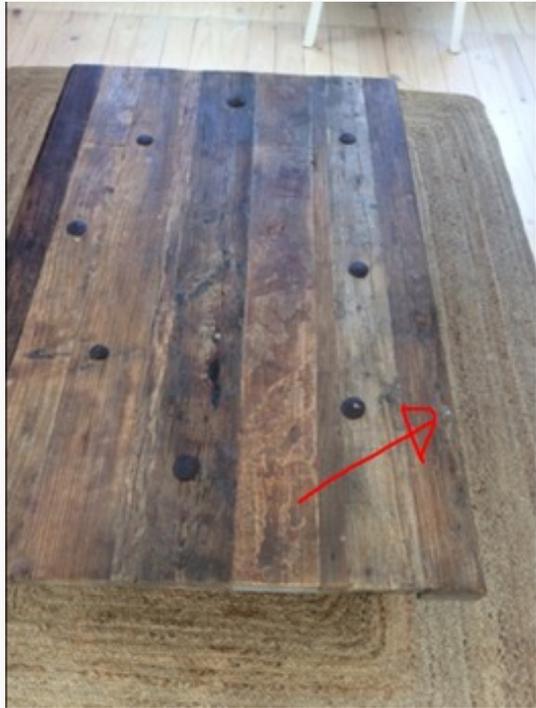
<p>The coffee table in the centre of the reception room has got a little bit of white paint markings. 31/03/2015 09:52 (CAT) at -34.1256150758713 ° , 18.4497218673937 °</p> </div> </div>
Windows	<div style="display: flex; align-items: center; justify-content: flex-end;"> New HandyMan </div> <p>Sash window behind the red couch is difficult to open. We need to repair. The other 2 sash windows in the living area/reception area work well and are able to open and close.</p>

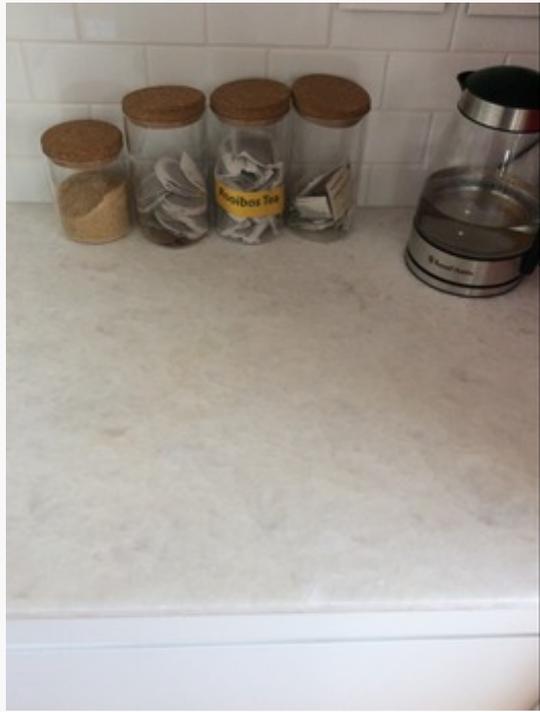
Item	Description
Counter-tops & Hardware	<p style="text-align: center;">New</p> <p>Countertops are marble, they are brand new, they are in excellent condition, although in the left hand sink there is a tiny chip to the top of the sink.</p> <div style="display: flex; justify-content: space-around;"> <div style="text-align: center;">

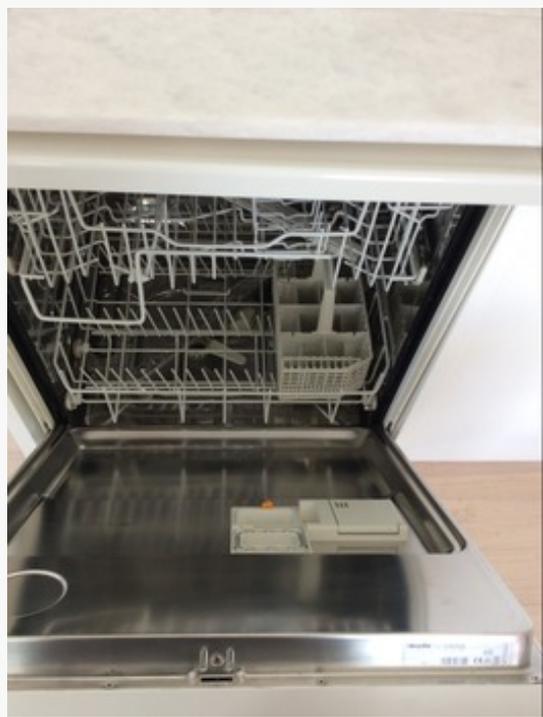
<p>31/03/2015 10:03 (CAT) at -34.1255810459905 ° , 18.4497474744478 °</p> </div> </div>
Dishwasher	<p style="text-align: center;">Damaged Plumber</p> <p>The dishwasher has all the trays and all the cutlery baskets and is intact. Identified it wasn't draining and we need to have that repaired.</p>

<table><tr> <td style="width: 60%;">Service Call</td> <td style="width: 20%; text-align: right;">R 1000.00</td> <td style="width: 20%; text-align: right;">Plus Tax</td> </tr><tr> <td>Repair Estimate</td> <td style="text-align: right;">R 3000.00</td> <td style="text-align: right;">Plus Tax</td> </tr></table>

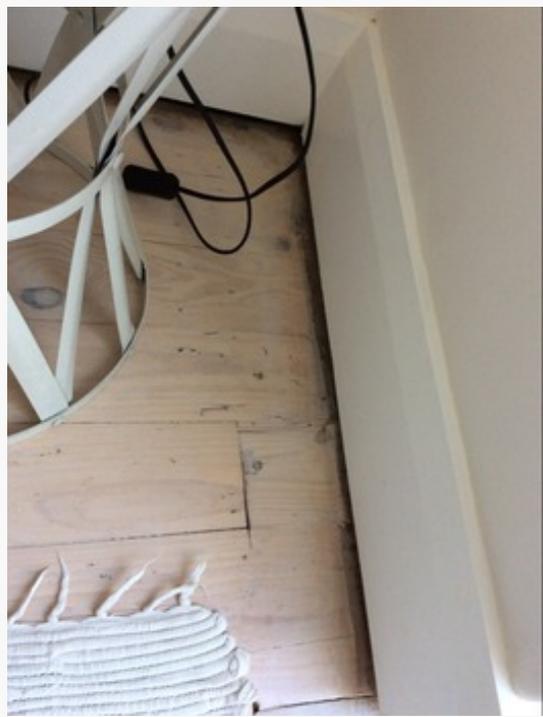
Item	Description
Floors	<p style="text-align: center;">Used</p> <p>The floors are wooden and have been lime wash painted; they are in good condition, there is evidence of previous borer beetle activity which I'm sure has been treated.</p>

<p>Evidence of previous borer beetle activity. 31/03/2015 10:11 (CAT) at -34.1255002116005 ° , 18.4498083010367 °</p>	<p>31/03/2015 10:11 (CAT) at -34.1255002116005 ° , 18.4498083010367 °</p>
Walls	Used

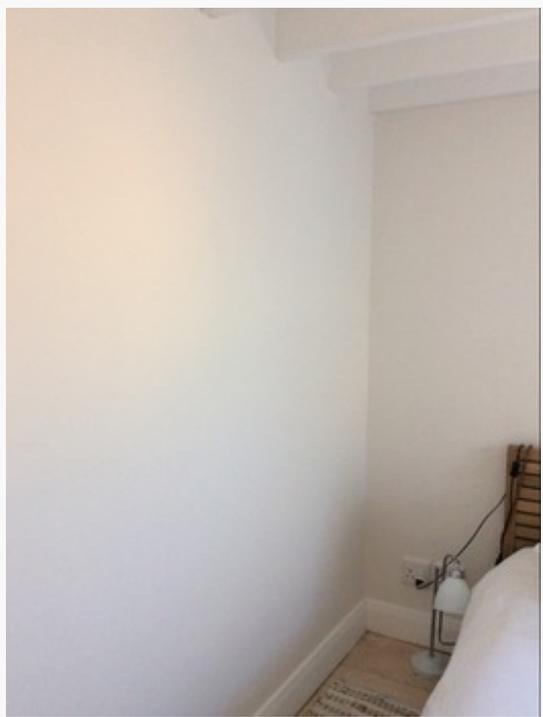
HandyMan
	<p>The walls in the main bedroom have been recently painted and are in good condition with 1 exception. On the right-hand side of the bed as you walk into the room, there are a few brown marks down the wall below the ceiling coving.</p>

</div> <p>Wall stained 31/03/2015 10:10 (CAT) at -34.1255002116005 ° , 18.4498083010367 °</p> <p>Costs</p> <table border="1" style="width: 100%; border-collapse: collapse;"> <tr> <td style="width: 60%;">Paint Touch-up</td> <td style="width: 20%; text-align: center;">R 900.00</td> <td style="width: 20%; text-align: center;">Plus Tax</td> </tr> </table> <p style="text-align: right;"> Net Total: R 900.00 Tax: R 180.00 Total : R 1080.00 </p>	Paint Touch-up	R 900.00	Plus Tax
Paint Touch-up	R 900.00	Plus Tax		
Windows	<p>New</p> <p>Windows in the main bedroom are all in good condition.</p>

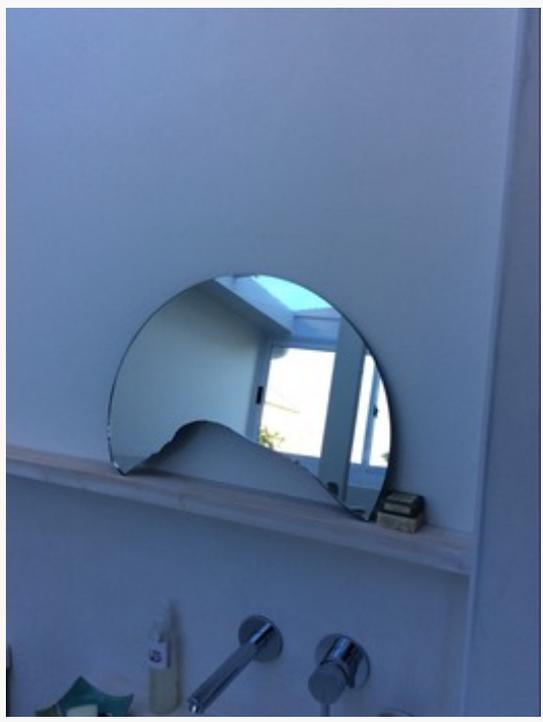
<p>31/03/2015 10:17 (CAT) at -34.1252001727271 ° , 18.4497695162751 °</p>
Mirror	<div style="background-color: #f0f0f0; padding: 5px; display: inline-block;"> Damaged </div> 🚩 Decorator
	The mirror in the main ensuite is broken.

</div> <p>31/03/2015 10:18 (CAT) at -34.1254443018437 ° , 18.4498006670273 °</p> <p>Costs</p> <table border="1" style="width: 100%; border-collapse: collapse;"> <tr> <td style="width: 60%;">Purchase replace mirror.</td> <td style="width: 20%; text-align: center;">R 2100.00</td> <td style="width: 20%; text-align: center;">Plus Tax</td> </tr> </table> <p style="text-align: right;"> Net Total: R 2100.00 Tax: R 420.00 Total : R 2520.00 </p>	Purchase replace mirror.	R 2100.00	Plus Tax
Purchase replace mirror.	R 2100.00	Plus Tax		
Room Total	All works this room (net): R 2100.00 Tax: R 420.00

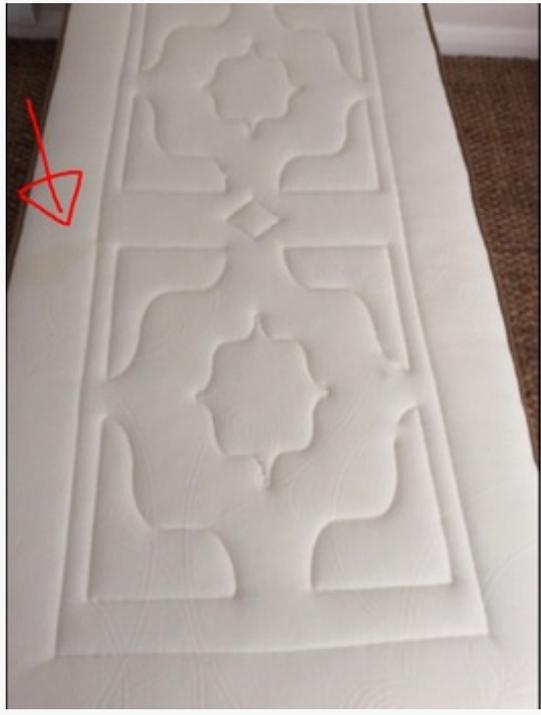
Mattress stain
31/03/2015 10:26 (CAT) at -34.1255317999163 ° ,
18.4497856551634 °

There is a stain on the 1 mattress, the single mattress that is not made up.
In the upstairs bedroom there are 6 pillows and 3 loose cushions.
There is 1 double bed and 2 single mattresses.
There is a 3-drawer chest of drawers, a shoe rack, and a kist.

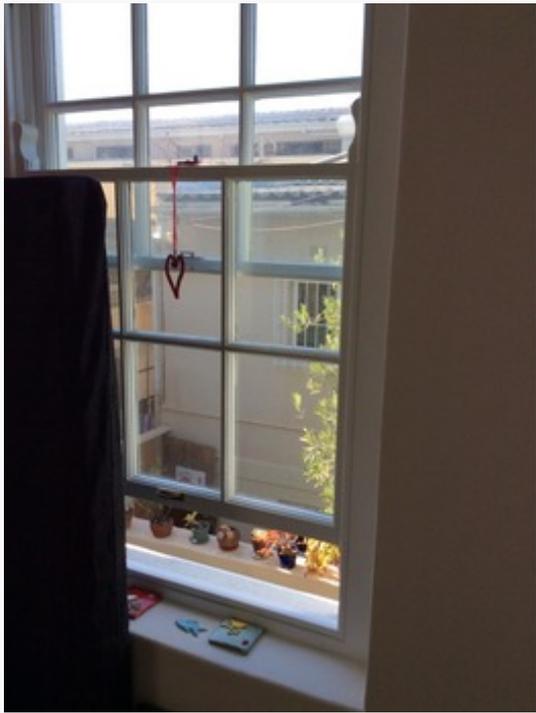
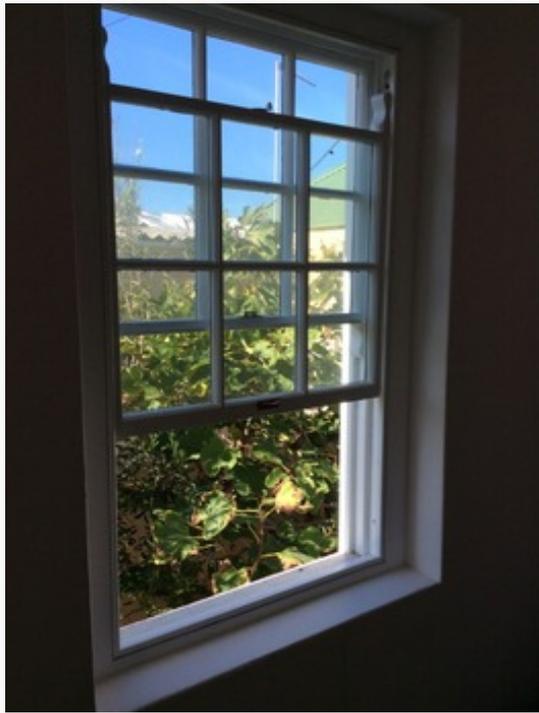
Item	Description			
Reception Room: Windows	<div style="text-align: right; margin-bottom: 5px;"> New 🚩 HandyMan </div> <p>Sash window behind the red couch is difficult to open. We need to repair. The other 2 sash windows in the living area/reception area work well and are able to open and close.</p> <div style="display: flex; justify-content: space-around;">

</div> <div style="display: flex; justify-content: space-around; font-size: small;"> <div style="text-align: center;">31/03/2015 09:58 (CAT) at -34.1254989761704 ° , 18.4498092306781 °</div> <div style="text-align: center;">31/03/2015 09:58 (CAT) at -34.1254989761704 ° , 18.4498092306781 °</div> </div> <p>Costs</p> <table border="1" style="width: 100%; border-collapse: collapse;"> <tr> <td style="width: 60%;">Lubricate sticking window</td> <td style="width: 20%; text-align: center;">R 900.00</td> <td style="width: 20%; text-align: center;">Plus Tax</td> </tr> </table> <p style="text-align: right; margin-top: 5px;"> Net Total: R 900.00 Tax: R 180.00 Total : R 1080.00 </p>	Lubricate sticking window	R 900.00	Plus Tax
Lubricate sticking window	R 900.00	Plus Tax		
Kitchen: Dishwasher	<div style="text-align: right; margin-bottom: 5px;"> Damaged 🚩 Plumber </div> <p>The dishwasher has all the trays and all the cutlery baskets and is intact. Identified it wasn't draining and we need to have that repaired.</p>

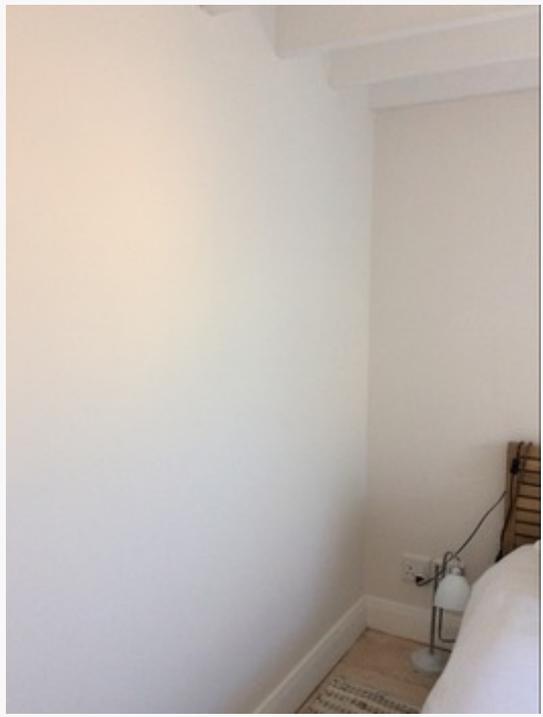
HandyMan									
	<p>The walls in the main bedroom have been recently painted and are in good condition with 1 exception. On the right-hand side of the bed as you walk into the room, there are a few brown marks down the wall below the ceiling coving.</p>

</div> <p>Wall stained 31/03/2015 10:10 (CAT) at -34.1255002116005 ° , 18.4498083010367 °</p> <p>Costs</p> <table border="1" style="width: 100%; border-collapse: collapse;"> <tr> <td style="width: 60%;">Paint Touch-up</td> <td style="width: 20%; text-align: right;">R 900.00</td> <td style="width: 20%; text-align: right;">Plus Tax</td> </tr> </table> <p style="text-align: right;"> Net Total: R 900.00 Tax: R 180.00 Total : R 1080.00 </p>	Paint Touch-up	R 900.00	Plus Tax
Paint Touch-up	R 900.00	Plus Tax		
Main En-suite: Ceiling	<p style="text-align: center;">New</p> <p style="text-align: right;">

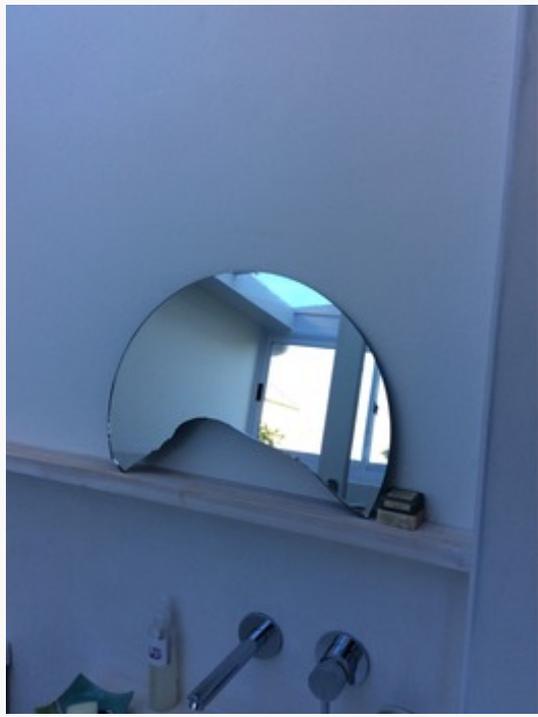
<p style="font-size: small; text-align: center;">31/03/2015 10:18 (CAT) at 0.0 ° , 0.0 °</p>
Main En-suite: Mirror	<p>Damaged Decorator</p> <p>The mirror in the main ensuite is broken.</p>

</div> <p style="font-size: small;">31/03/2015 10:18 (CAT) at -34.1254443018437 ° , 18.4498006670273 °</p> <p>Costs</p> <table border="1" style="width: 100%; border-collapse: collapse;"> <tr> <td style="width: 60%;">Purchase replace mirror.</td> <td style="width: 20%; text-align: center;">R 2100.00</td> <td style="width: 20%; text-align: center;">Plus Tax</td> </tr> <tr> <td colspan="3" style="text-align: right;"> Net Total: R 2100.00 Tax: R 420.00 Total : R 2520.00 </td> </tr> </table>	Purchase replace mirror.	R 2100.00	Plus Tax	Net Total: R 2100.00 Tax: R 420.00 Total : R 2520.00		
Purchase replace mirror.	R 2100.00	Plus Tax					
Net Total: R 2100.00 Tax: R 420.00 Total : R 2520.00							
Laundry Room: Wash Basin	<p style="text-align: center;">New</p> <p>Left hot tap in the kitchen laundry sink area is dripping.</p> <p style="text-align: right; color: #C00000;"> HandyMan</p>
