Clarke &
Vaughan
Associates

Full Building Survey: Sample Generic Building Survey

Inspected by: Vera Watts

Date of Inspection: 01 February 2017

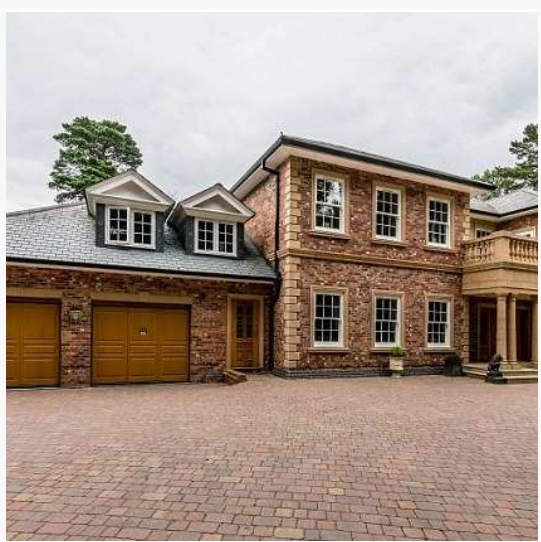
Double Garages.jpg
01/02/2017 15:07 (GMT)

The garages have an asphalted flat and gently sloping roof and it appears that part of the original garages have been incorporated within the construction. The asphalt roof has been repaired in the past with a number of felted patch repairs and bitumen painted on repairs and remains generally serviceable. It requires general sweeping of pine needles and leaves from the adjacent trees from time to time in order to maintain free drainage and the asphalted covering with some minor repairs should suffice for a number of years yet.

There are some painted on repairs adjacent to the small front upstand as well as a blocked outlet to the roof that requires cleaning. The gutter to the right hand side requires cleaning of leaves but otherwise the roof remains serviceable. The timber clad fascia to the front of the building remains serviceable and the brickwork remains in satisfactory order. It is evident to the right hand side of the building that the garaging is formed in differing ages of construction with there being a fairly piecemeal arrangement along the right hand side of old brickwork that has been repaired, flint faced panelling and also newer brickwork that is wrapped around the front of the building to match that used on the main house.

Internally within the left hand garage the ceiling soffit is boarded in a painted board that is damaged in a small number of areas and from the date of construction could well be asbestos based. Some of this boarding should be sent away for analysis and if found to be asbestos then ideally the boarding should be either encapsulated to prevent the loss of any free fibres or removed completely under controlled conditions.

The external wall to the original garage remains and this shows evidence of some cracking defects with stepped cracking on the wall to the right hand side of the garage adjacent to the front pier most likely as a result of some sub-structure movement possibly at the time when the heavy brick pier to the front was installed. There is a further lesser crack approximately halfway along the garage that again is thought to be due to slight foundation movement.
