In-going

9 Tokai Road
Constantia
Cape Town
7700

Date Published: 31 March 2015

Date of Inspection: 31/03/2015

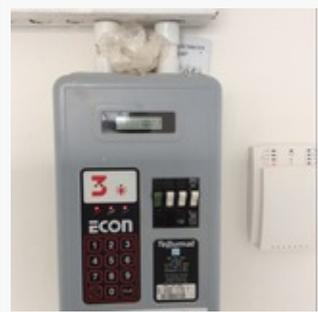
Serial #: QWERTY-1
Reading One: 108.3
Supplier: Eskom
Location: Outside right

The electricity card is present and the geyser is switched on.

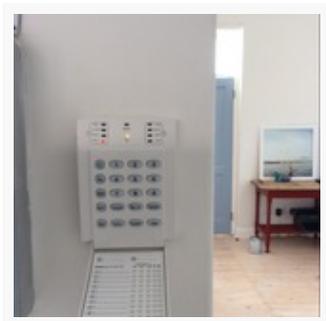
Serial #: POP-27L
Location: Entry wall

31/03/2015 10:23 (CAT) at
-34.1256294250046 ° ,
18.4497127533153 °
The Alarm box is a "Paradox" and is in good working order.

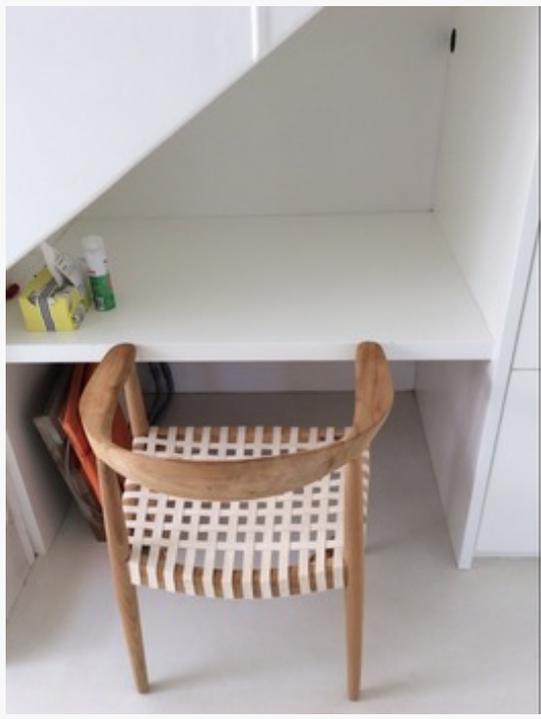
Item	Description
Floors	<p style="text-align: center;">New</p> <p>Floors in this area have recently been screeded and are in good condition.</p>

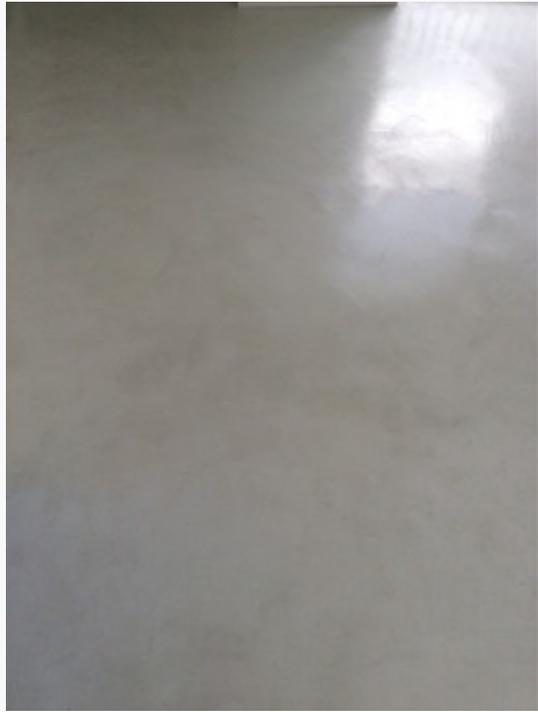
<p>Unmarked, new flooring 2 31/03/2015 10:19 (CAT) at -34.1255061941308 ° , 18.4497737736608 °</p> </div> <div style="width: 45%;">

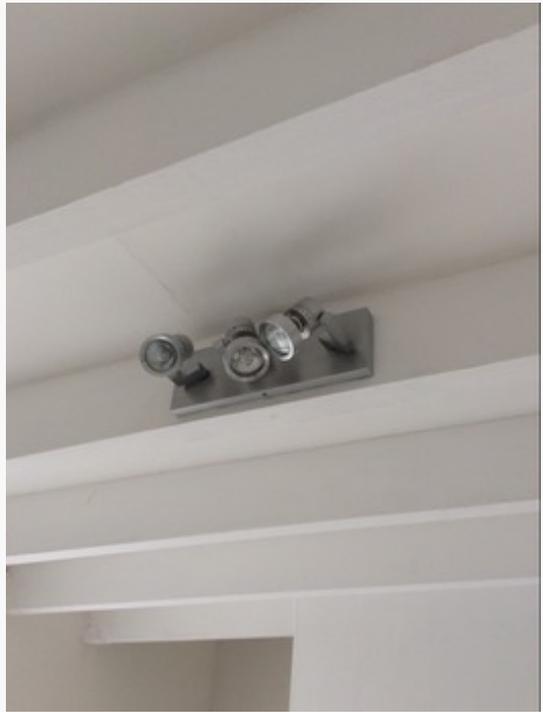
Item	Description
Lights & Fixtures	<p style="text-align: center; background-color: #e0e0e0;">New</p> <p>Fixtures in excellent working condition</p> <div style="text-align: center;">

</div> <p>Ceiling spotlights 31/03/2015 10:20 (CAT) at -34.1256459448728 ° , 18.4497009453976 °</p>
Stairs	<p style="text-align: center; background-color: #e0e0e0;">New</p> <p>Hand rail on left side of wall going up stairs The walls going up the stairway have a few grubby marks on but nothing that can't be washed clean.</p>

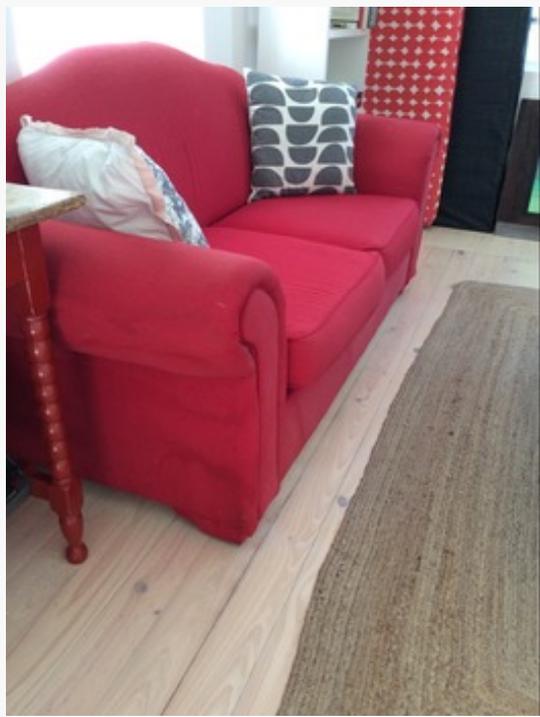
The red sofa has a few water marks on the front side and on the arm side of the sofa, just to note that these are in existence.

<p>The red sofa has 2 cushions fixed, 4 loose cushions for seating and 2 single grey and white cushions, 1 with flowers and 1 with half moons. 31/03/2015 09:44 (CAT) at -34.1256150758713 ° , 18.4497218673937 °</p> </div> <div style="width: 45%;">

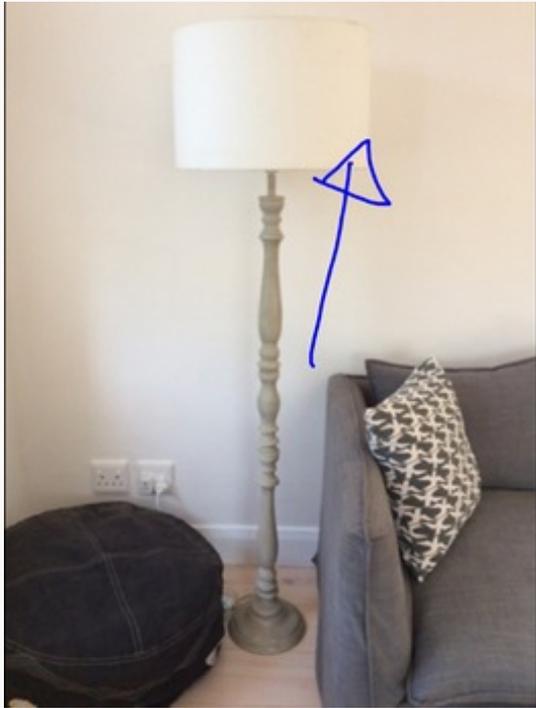
<p>Blue/black denim bean bag with beaded work on it. The standard lamp has a white shade, which is marked. 31/03/2015 09:50 (CAT) at -34.1256150758713 ° , 18.4497218673937 °</p> </div> <div style="width: 45%;">

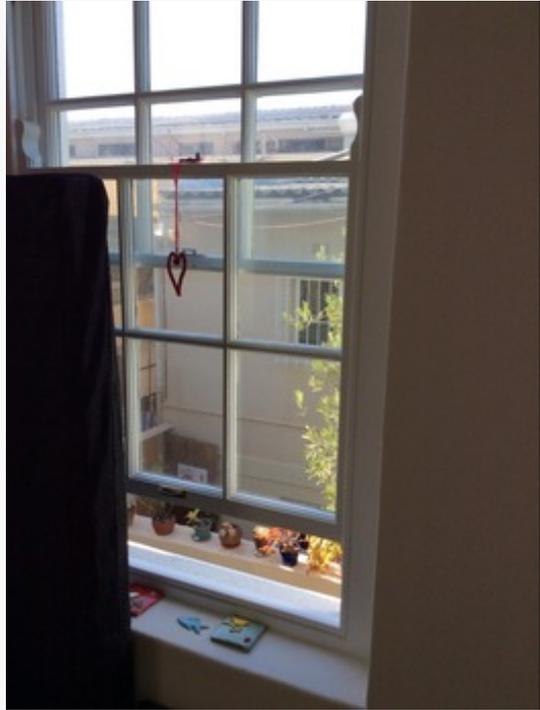
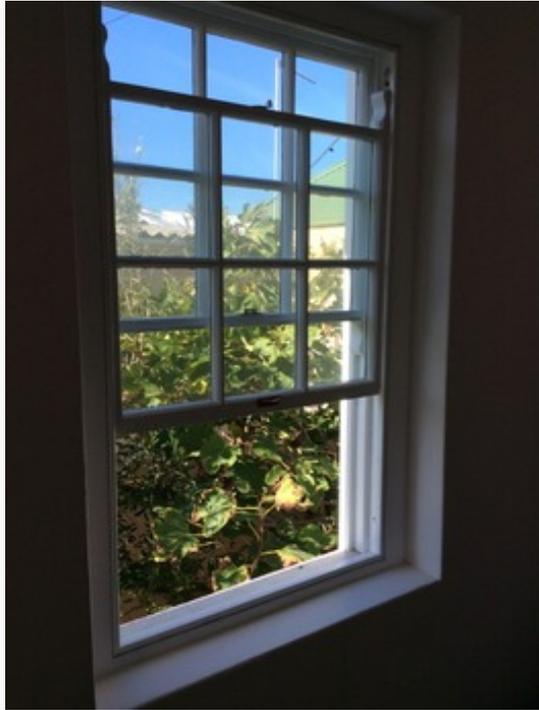
Item	Description			
Reception Room: Windows	<div style="text-align: right; margin-bottom: 5px;"> New 🚩 HandyMan </div> <p>Sash window behind the red couch is difficult to open. We need to repair. The other 2 sash windows in the living area/reception area work well and are able to open and close.</p> <div style="display: flex; justify-content: space-around;">

<p>31/03/2015 09:58 (CAT) at -34.1254989761704 ° , 18.4498092306781 °</p> </div> </div> <p>Costs</p> <table border="1" style="width: 100%; border-collapse: collapse;"> <tr> <td style="width: 60%;">Lubricate sticking window</td> <td style="width: 20%; text-align: center;">R 900.00</td> <td style="width: 20%; text-align: center;">Plus Tax</td> </tr> </table> <p style="text-align: right; margin-right: 20px;"> Net Total: R 900.00 Tax: R 180.00 Total : R 1080.00 </p>	Lubricate sticking window	R 900.00	Plus Tax
Lubricate sticking window	R 900.00	Plus Tax		
Room Total	All works this room (net): R 900.00 Tax: R 180.00

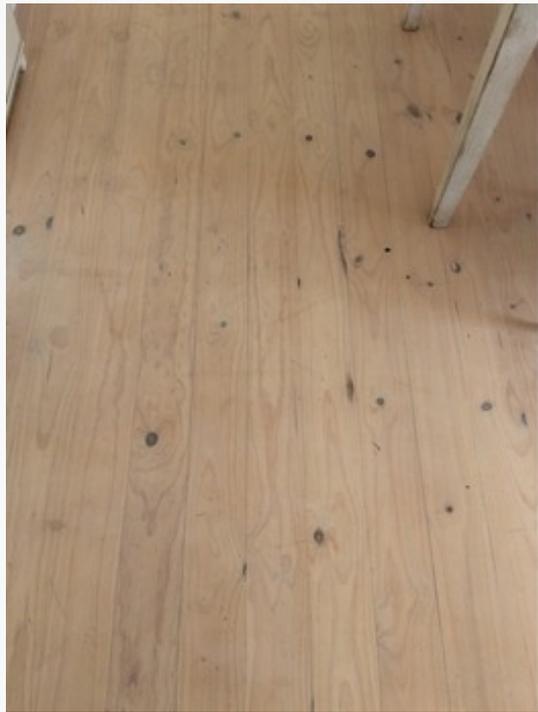
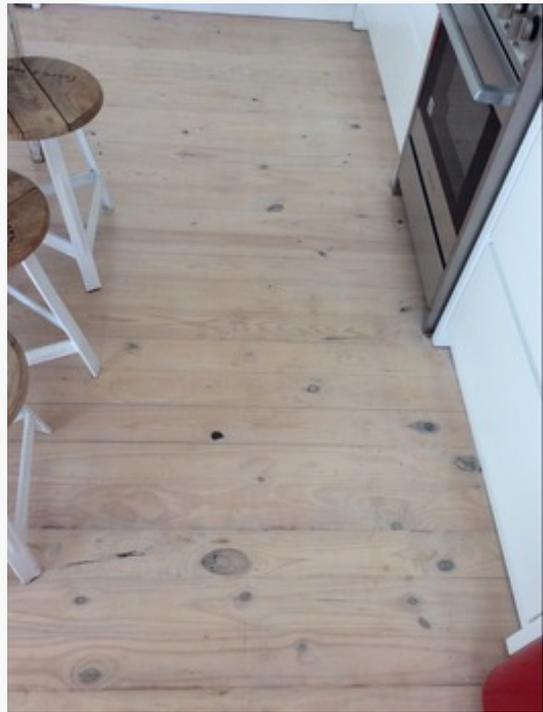
Item	Description
Floors	<div style="display: flex; justify-content: space-between;"> <div style="width: 45%;"> <p>Wood</p> <p>New</p> <p>The floors have been newly painted however there are a few scuff marks and a few minor stains. Floors appear prone to marking.</p> </div> <div style="width: 45%;">

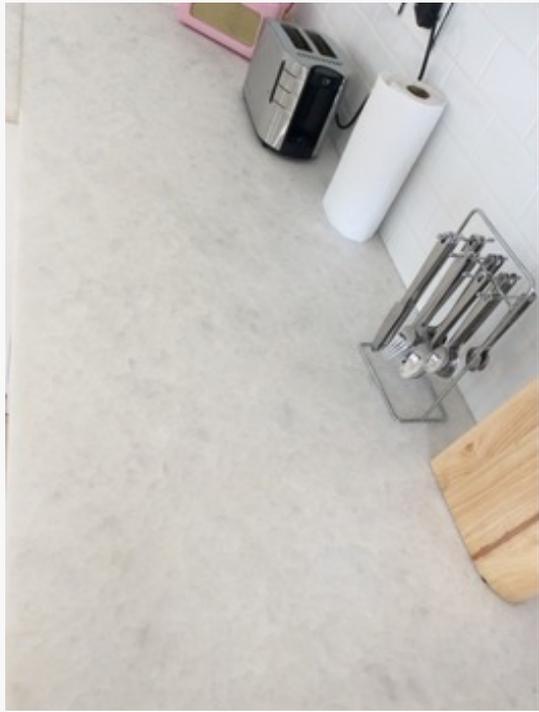
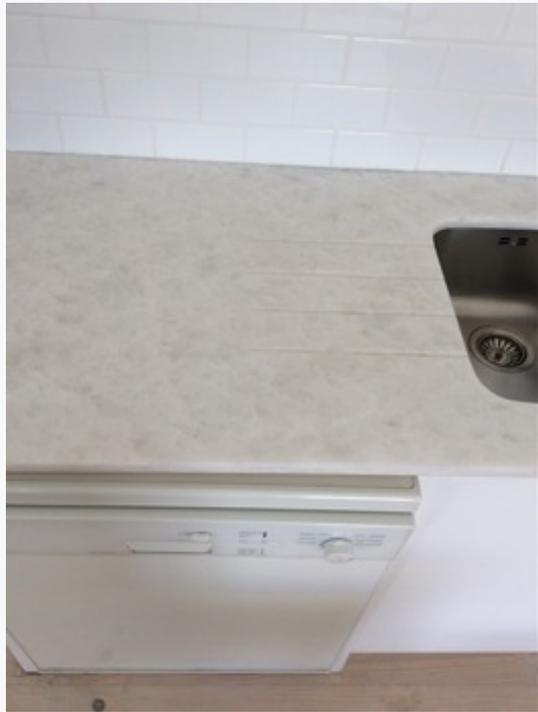
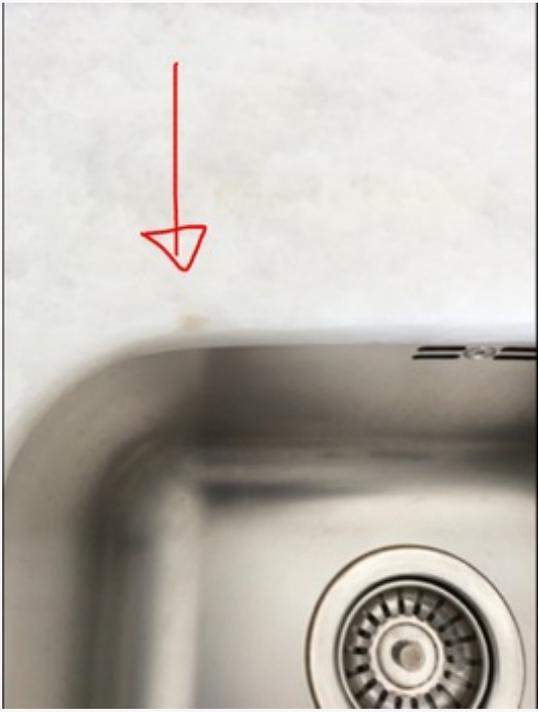
Item	Description
Counter-tops & Hardware	<p style="text-align: center;">New</p> <p>Countertops are marble, they are brand new, they are in excellent condition, although in the left hand sink there is a tiny chip to the top of the sink.</p> <div style="display: flex; justify-content: space-around;"> <div style="text-align: center;">

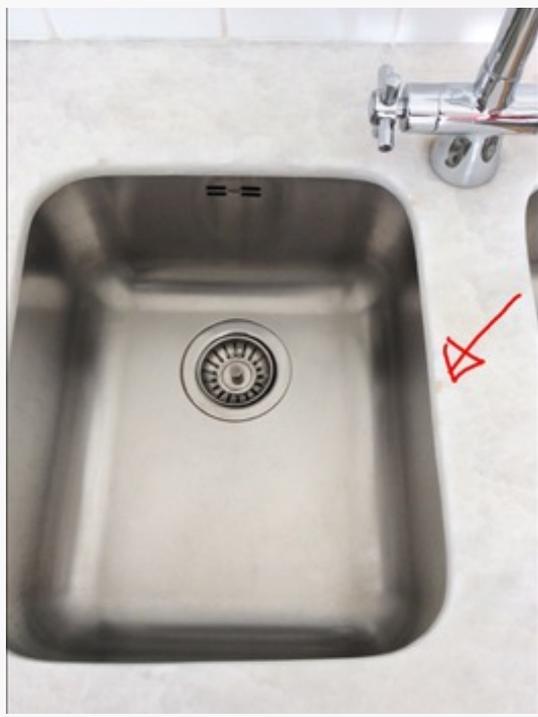
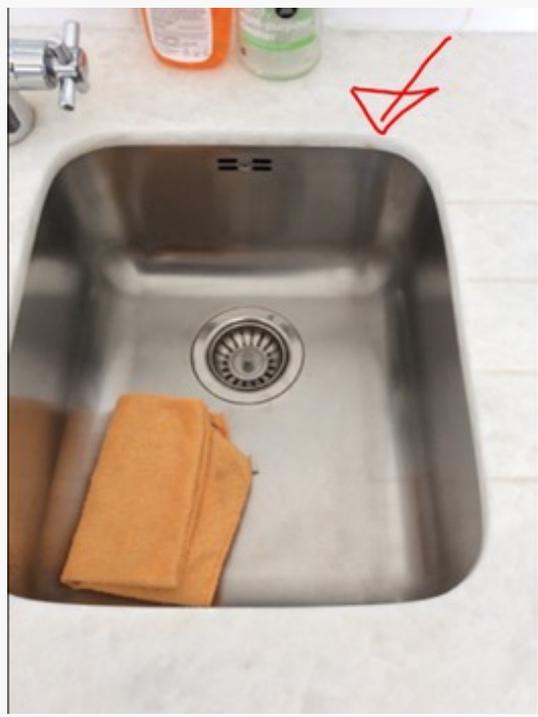
<p>31/03/2015 10:03 (CAT) at -34.1255810459905 ° , 18.4497474744478 °</p> </div> </div>
Sink	<p style="text-align: center;">New</p> <p>Both stainless steel sinks in good condition, both plugs are intact and all is well. There are a few stain marks on the marble counter at the rim of each sink. I have indicated in the photos.</p>

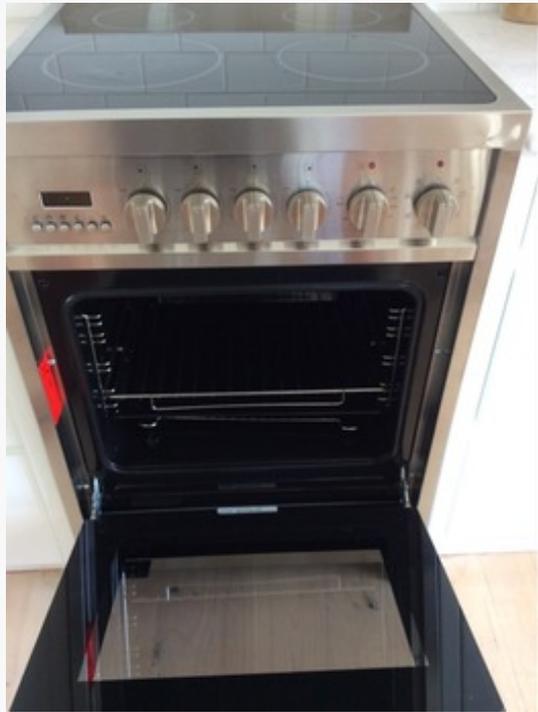
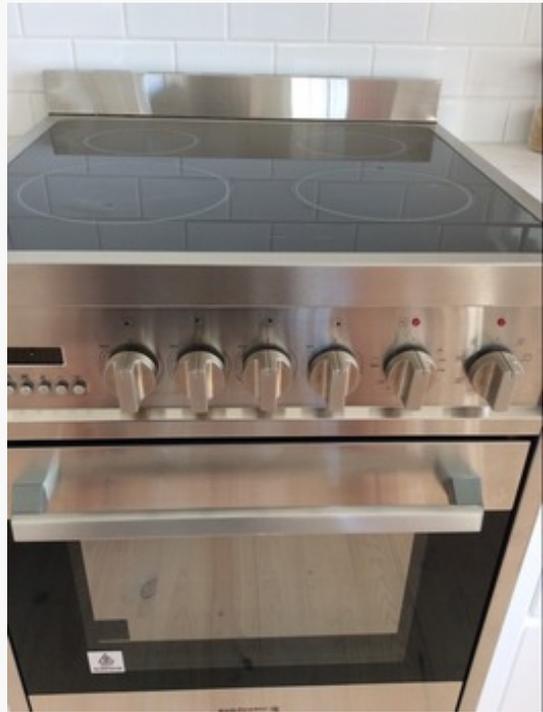
<p>31/03/2015 10:07 (CAT) at -34.1256197330007 ° , 18.4497183630898 °</p> </div> </div>
Hob/Oven	<p>Used</p> <p>On the Kelvinator hob on the front left plate it looks a little bit worn, used, or marked.</p>

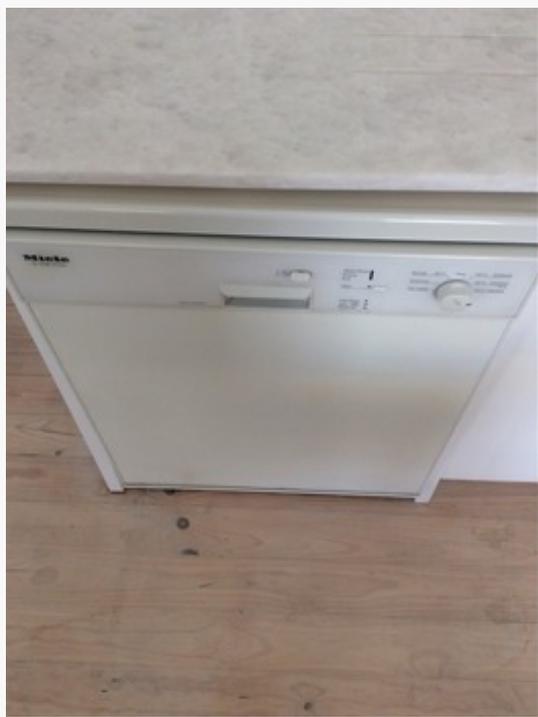
<p>31/03/2015 10:03 (CAT) at -34.1255810459905 ° , 18.4497474744478 °</p> </div> </div>
Dishwasher	<p style="text-align: center;">Damaged Plumber</p> <p>The dishwasher has all the trays and all the cutlery baskets and is intact. Identified it wasn't draining and we need to have that repaired.</p>

<table><tr> <td style="width: 60%;">Service Call</td> <td style="width: 20%; text-align: right;">R 1000.00</td> <td style="width: 20%; text-align: right;">Plus Tax</td> </tr><tr> <td>Repair Estimate</td> <td style="text-align: right;">R 3000.00</td> <td style="text-align: right;">Plus Tax</td> </tr></table>

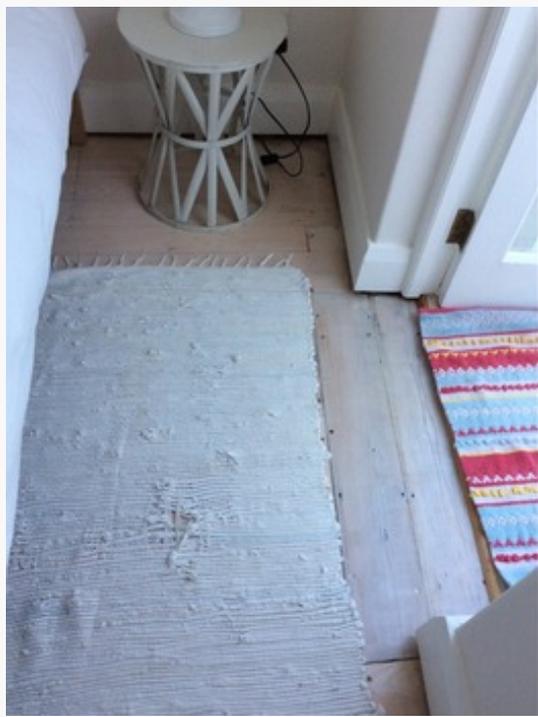
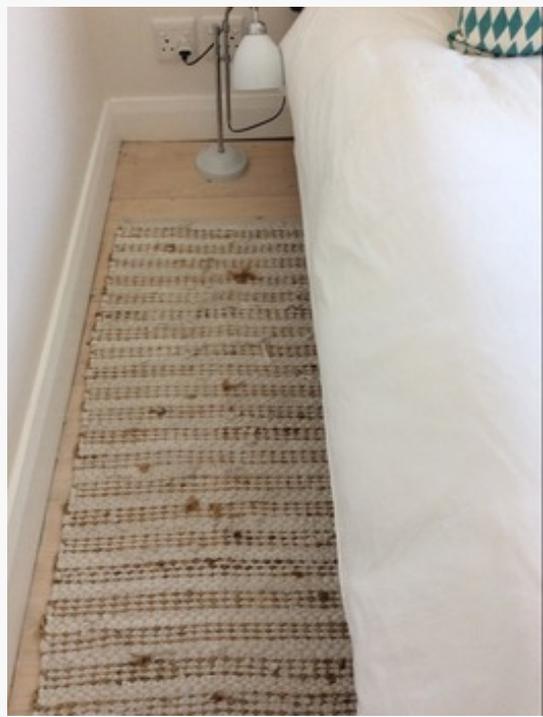
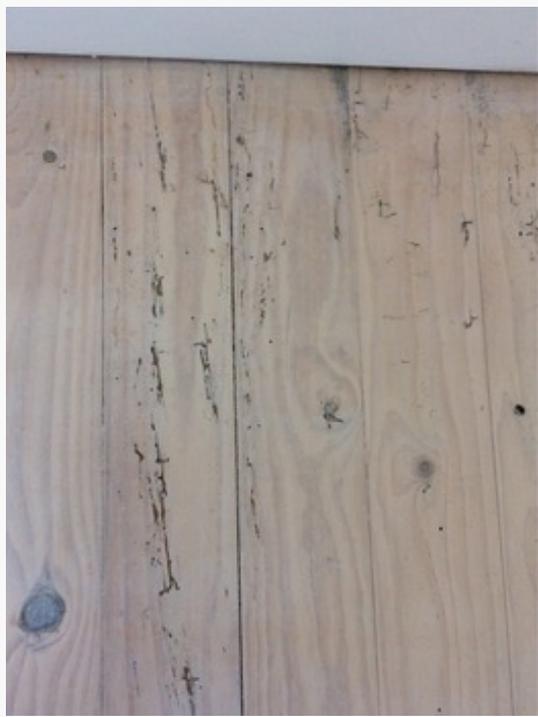
Item	Description
Floors	<p style="text-align: center;">Used</p> <p>The floors are wooden and have been lime wash painted; they are in good condition, there is evidence of previous borer beetle activity which I'm sure has been treated.</p>

<p>Evidence of previous borer beetle activity. 31/03/2015 10:11 (CAT) at -34.1255002116005 ° , 18.4498083010367 °</p>	<p>31/03/2015 10:11 (CAT) at -34.1255002116005 ° , 18.4498083010367 °</p>
Walls	Used

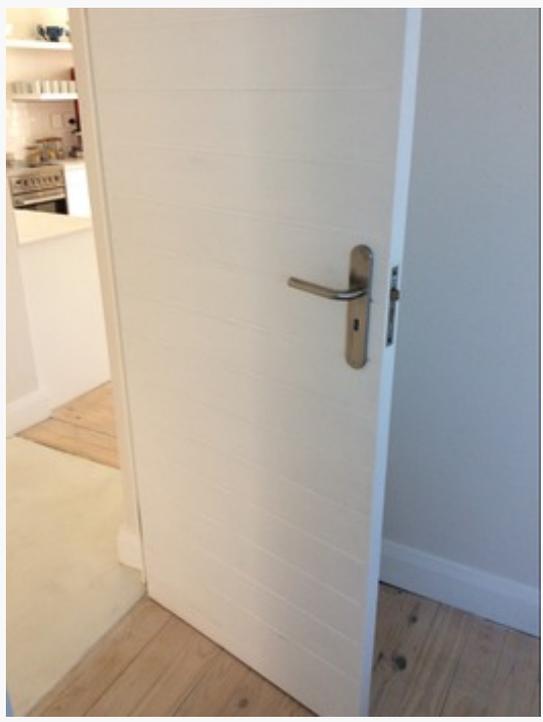
<p>31/03/2015 10:12 (CAT) at -34.1255002116005 ° , 18.4498083010367 °</p>
Doors & Hardware	<p>New</p> <p>The door in the main bedroom is new although at the bottom there seems to be a few scuff marks probably from moving suitcases in and out. There is a grass laundry basket behind the door in the main bedroom.</p>

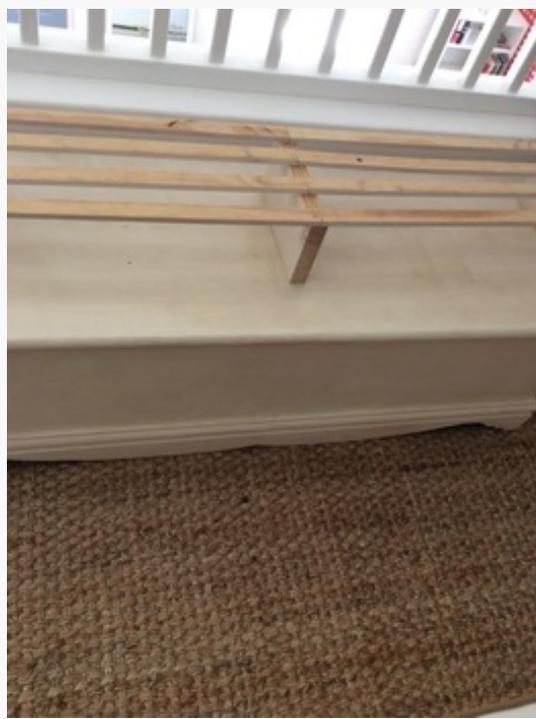
There is a stain on the 1 mattress, the single mattress that is not made up.
In the upstairs bedroom there are 6 pillows and 3 loose cushions.
There is 1 double bed and 2 single mattresses.
There is a 3-drawer chest of drawers, a shoe rack, and a kist.

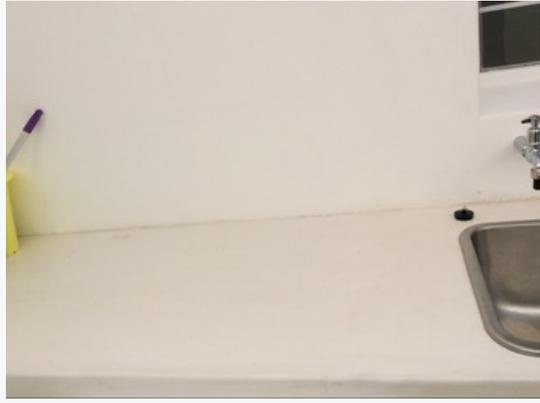
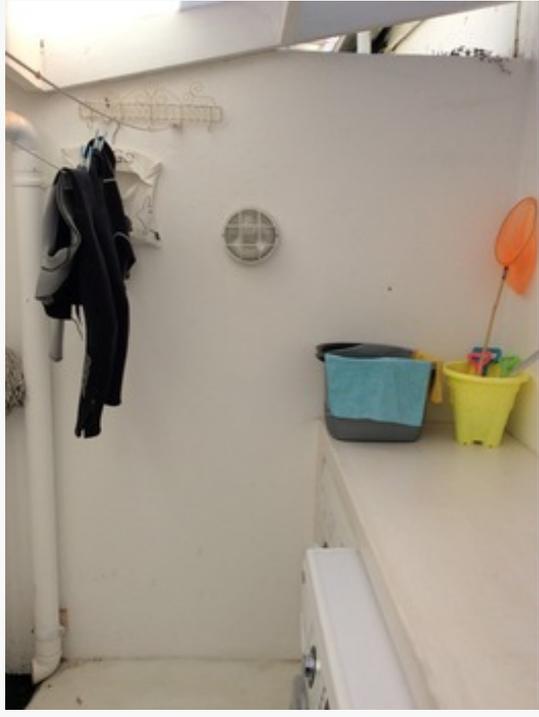
<p>31/03/2015 10:30 (CAT) at 0.0 ° , 0.0 °</p> </div> </div>
Washer & Dryer	<div style="text-align: center; background-color: #f0f0f0; padding: 5px;">Used</div> <p>The dryer is a Bosch and the washer is an LG Direct Drive 8KG.</p> <div style="display: flex; justify-content: space-around;"> <div style="text-align: center;">

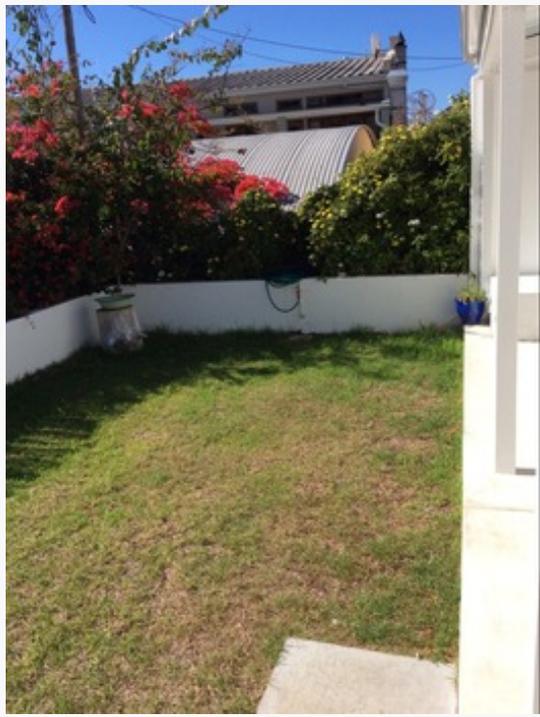
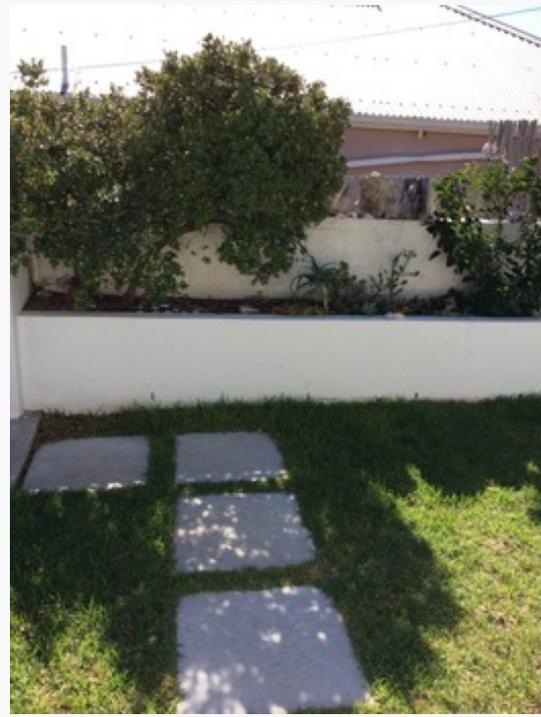
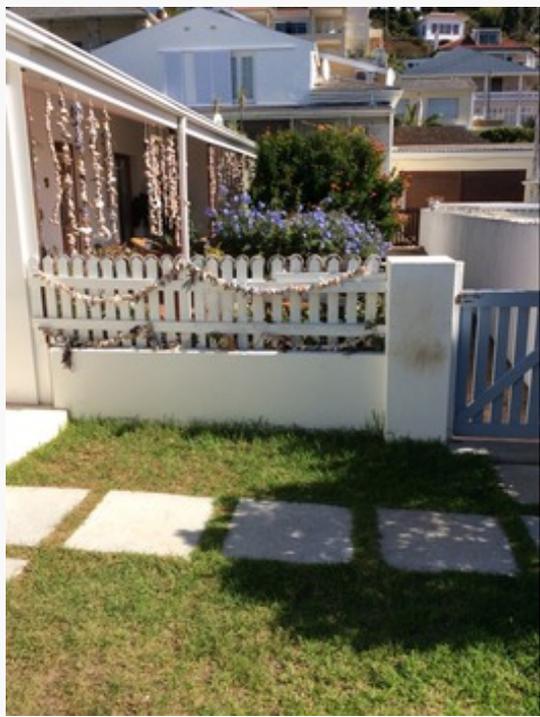
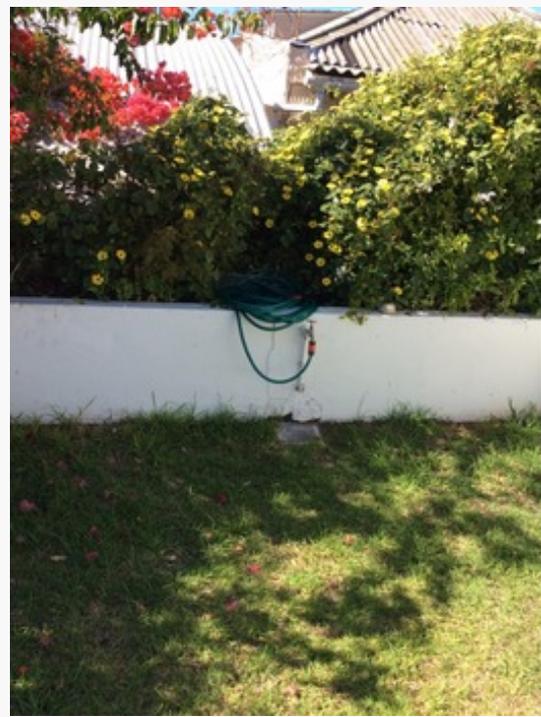
Front Garden

Front garden is neat and tidy. There is an outside bench and an outside trestle table. The lawn service comes every 2 weeks on a Friday to cut the lawn. They are called Hedgehogs. There is a hose pipe with all the attachments.

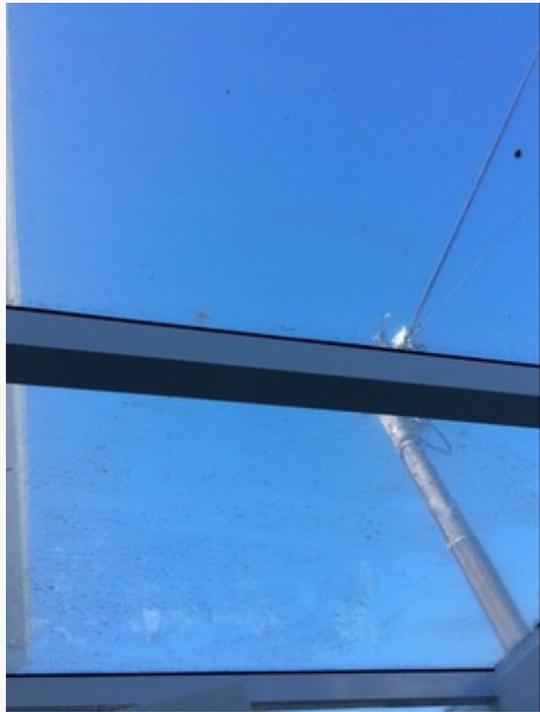
Item	Description
Main En-suite: Ceiling (continued)

<p style="font-size: small; text-align: center;">31/03/2015 10:18 (CAT) at 0.0 ° , 0.0 °</p>
Main En-suite: Mirror	<p>Damaged Decorator</p> <p>The mirror in the main ensuite is broken.</p>

</div> <p style="font-size: small;">31/03/2015 10:18 (CAT) at -34.1254443018437 ° , 18.4498006670273 °</p> <p>Costs</p> <table border="1" style="width: 100%; border-collapse: collapse;"> <tr> <td style="width: 60%;">Purchase replace mirror.</td> <td style="width: 20%; text-align: center;">R 2100.00</td> <td style="width: 20%; text-align: center;">Plus Tax</td> </tr> <tr> <td colspan="3" style="text-align: right;"> Net Total: R 2100.00 Tax: R 420.00 Total : R 2520.00 </td> </tr> </table>	Purchase replace mirror.	R 2100.00	Plus Tax	Net Total: R 2100.00 Tax: R 420.00 Total : R 2520.00		
Purchase replace mirror.	R 2100.00	Plus Tax					
Net Total: R 2100.00 Tax: R 420.00 Total : R 2520.00							
Laundry Room: Wash Basin	<p style="text-align: center;">New</p> <p>Left hot tap in the kitchen laundry sink area is dripping.</p> <p style="text-align: right; color: #C00000;"> HandyMan</p>
