Clarke &
Vaughan
Associates

Full Building Survey: Sample Generic Building Survey

Inspected by: Vera Watts

Date of Inspection: 01 February 2017

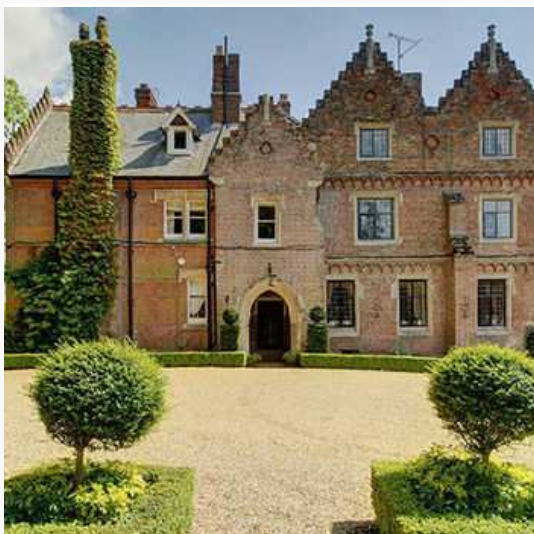
Main House
01/02/2017 15:07 (GMT)

The house is an architecturally designed building we understand constructed around the early 1870s.
